Thermographic Report

External | Roof / Elevations from Car Park

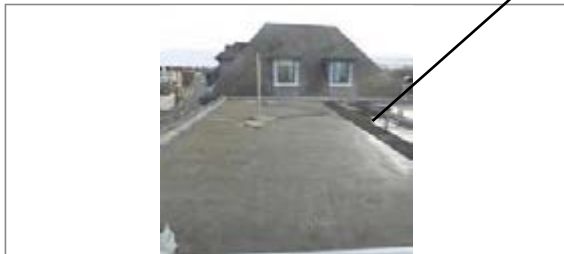
When first observing a thermogram, it is important to look at the scene in general and not be drawn into finding so called 'hotspots'. Instead, try to observe different and otherwise inconsequential details such as the colour of the ground and vegetation which are after all natural and unheated objects. This gives a reference point to start judging the effectiveness of the building elevations. Several areas of standing water can clearly be seen, as indicated in the circled area.

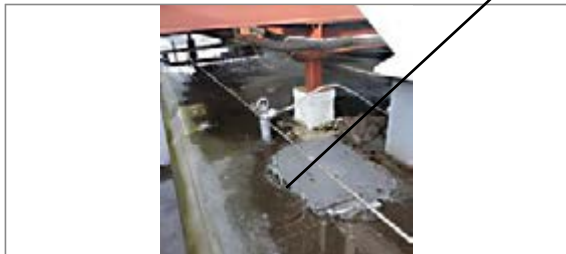
External | Roof / Elevation from Car Park

White circled areas show reflection of cold sky and can be disregarded from the report.

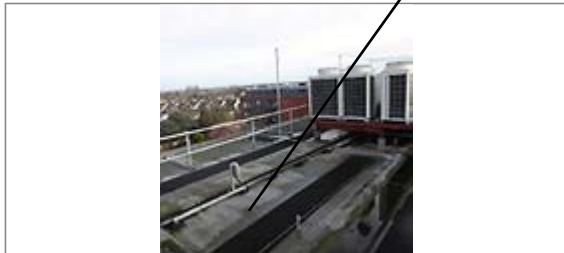
External | Roof shot from Car Park

Black circled area potentially shows area of heat loss, which would suggest poor missing insulation. This could also be water ingress beneath the roof covering which shows warm due to higher thermal capacitance of moisture. White circled area shows vents, which can be disregarded.

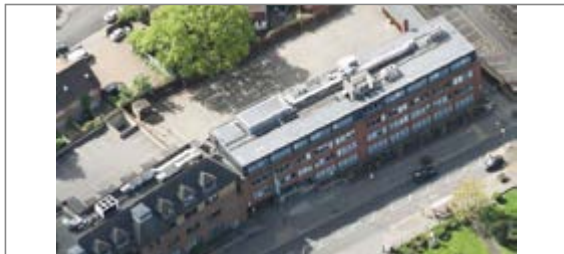
External | Roof shot from Car Park

Several areas have been highlighted which show areas of possible discontinuity of insulation.
